OPERATING EXPERIENCE WEEKLY SUMMARY

Office of Nuclear and Facility Safety

August 21 - August 27, 1998

Summary 98-34

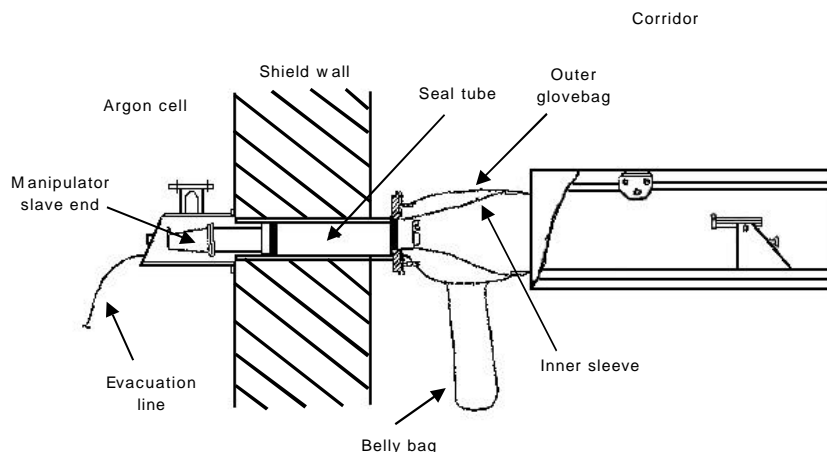
Figure 1-1. Seal Tube Set-up

The work plan required workers to remove, repair, and replace a seal tube between the operations corridor and the argon cell (a hot cell with argon gas atmosphere) through a 5-foot-thick shield wall. In-cell confinement is established by placing a can over the seal tube in the argon cell, then raising cell pressure to approximately -1.0 inch of water. The can is evacuated to ensure that any leakage is into the can. Leakage is then exhausted to the air cell exhaust system (see Figure 1-1).

Investigators suspect that contamination leakage occurred while operators were moving the seal tube into the penetration. They believe the source of the contamination was the slave end of the manipulator seal tube and that contamination escaped through the seal between a mobile glovebox and the seal tube penetration flange. The Argonne National Laboratory-West emergency action manager declared an alert. The building emergency director ordered personnel to evacuate the facility. Investigators are continuing to determine the cause of this occurrence. OEAF engineers will follow the investigation and provide information as it becomes available.

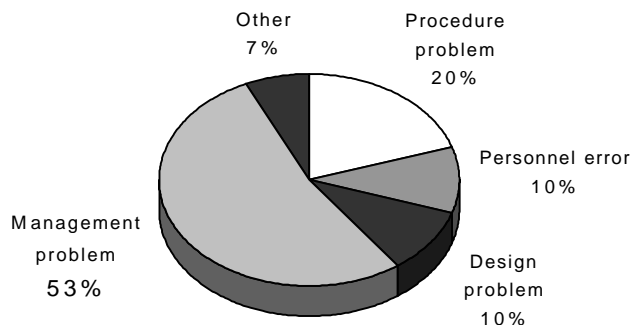
Figure 3-1. Distribution of Root Causes for Gas Line Ruptures¹

OEAF engineers conducted a search of the ORPS database for occurrences involving inadvertent release of natural gas or propane and identified 30 occurrences related to construction activities. A review of these occurrences shows that managers reported 53 percent as management problems and 20 percent as procedure problems. Figure 3-1 displays the distribution of root causes for these events. Further review of the management problems shows that 31 percent were reported as inadequate administrative control, and 31 percent were reported as policy not adequately defined, disseminated, or enforced.

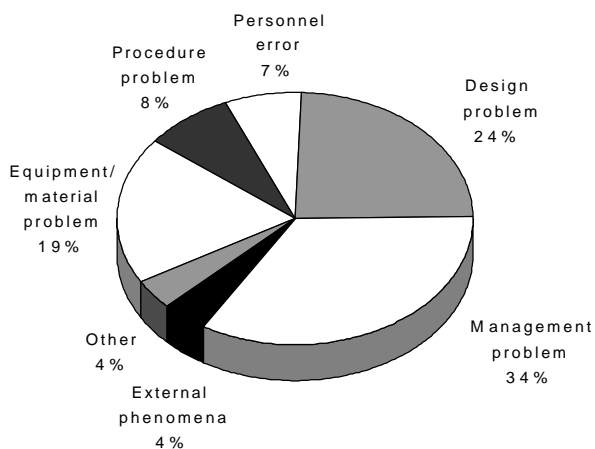
Figure 4-1. Distribution of Root Causes for Freeze Protection Events¹

OEAF engineers searched the entire ORPS database and found 479 freeze protection events. Figure 4-1 shows the root causes for these events. A review of these events shows that 34 percent of these events were attributed to management problems, with an additional 24 percent attributed to design problems. Further analysis revealed that 30 percent of management problems were attributed to work organization/planning deficiencies; an additional 29 percent were attributed to inadequate administrative control. This indicates that if facility managers convey the importance of thorough freeze protection plans to employees responsible for developing them, many events could be avoided. Figure 4-2 shows the distribution by nature of occurrence for these events. A review by nature of occurrence shows that 58 percent of freeze protection events affected the facility condition. Further analysis revealed that 43 percent of events affecting facility condition were attributed to vital system/component degradation; an additional 34 percent affected operations. Site reviewers should use lessons learned from these

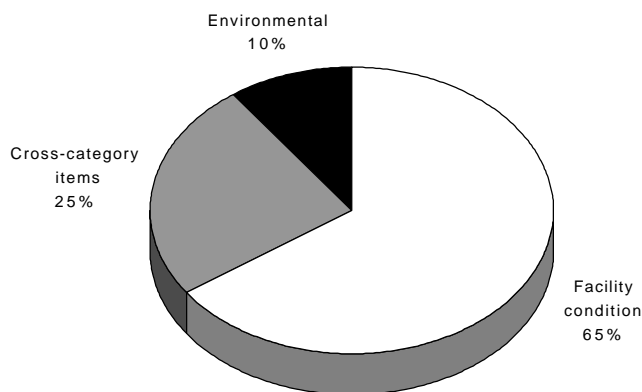
Figure 4-2. Distribution of Nature of Occurrences for Freeze Protection Events¹

¹ OEAF engineers searched the entire ORPS database using the graphical users interface for all narrative "freeze AND protection" and found 479 events that identified 531 nature of occurrences. Based on a random sampling of 25 events, OEAF engineers determined that each slice is accurate within ± 2 percent.
